## EMERGENCY PURCHASE REPORT

1. Date Emergency situation first noted/occurred (time and date): 10/31/22 – GW Operations utilized D&R tank for an inspection of Volcano Cliffs Reservoirs 1 and 2 based on concerns about the condition of the reservoir vents (on top of the reservoirs in the middle) that had been noted on several other reservoirs in the Corrales Trunk.

Re: Aluminum Vent Replacement – Volcano Cliffs Reservoir 2 (2005 BMT)

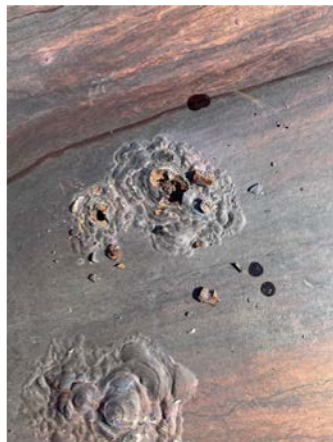
2. Describe emergency situation – Be very specific (attach additional pages, if required): During the inspection, D&R and GW personnel noted full penetration corrosion spots on the steel reservoir roof plates immediately adjacent to the 24” diameter vent riser (in the center of the reservoir roof). The visible corrosion area measures 18” x 18”, and will require cutting out a 12-ft. diameter roof section centered around the vent, and welding a new fabricated steel roof section and new vent. Once the corroded section is removed, the reservoir rafter beams will need to be inspected, cleaned, and recoated potentially repaired/replaced, and have the coatings tested for thickness.

This work will require draining and cleaning the reservoir, and will require scaffolding placement inside the tank, and T this work will need to be completed during the next 1-2 months, thus necessitating this Emergency Purchase request. The work will need to be completed by D&R tank, an experienced tank contractor, and will involve approval of an initial cost quote from D&R tank, followed by a potential cost adjustment, depending on the extent and degree of corrosion found during the roof section removal/replacement.

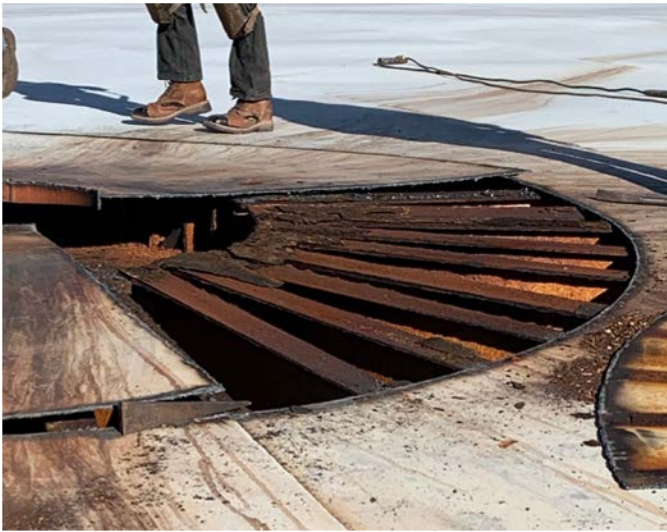
Once the corroded roof plate was removed, the beams were inspected. The roof beams are heavily corroded, as shown below. They need to be cleaned, sandblasted, and have the protective coating repaired prior to replacing the roof plates and returning the reservoir to service to protect the beams from further corrosion. This was not included in the original proposal price.

D&R Tank Co will provide all supervision, labor, material, tools, and equipment to field sandblast and recoat rafters in a 12' diameter area at the vent location interior and exterior prior to the installation of the new 12' Diameter plate at center vent.
